ISTFA 2015 Abstract

X-Ray Microscopy and Root Cause Analysis in Electronic Packaging

L. Mirkarimi, A. Gu, L. Hunter and R. Estrada
Carl Zeiss X-Ray Microscopy, 4385 Hopyard Road, Suite 100 Pleasanton, CA 94588

G. Guevara, M. Huynh and R. Katkar
Invensas Corporation, 3025 Orchard Pkwy, San Jose, CA 95134

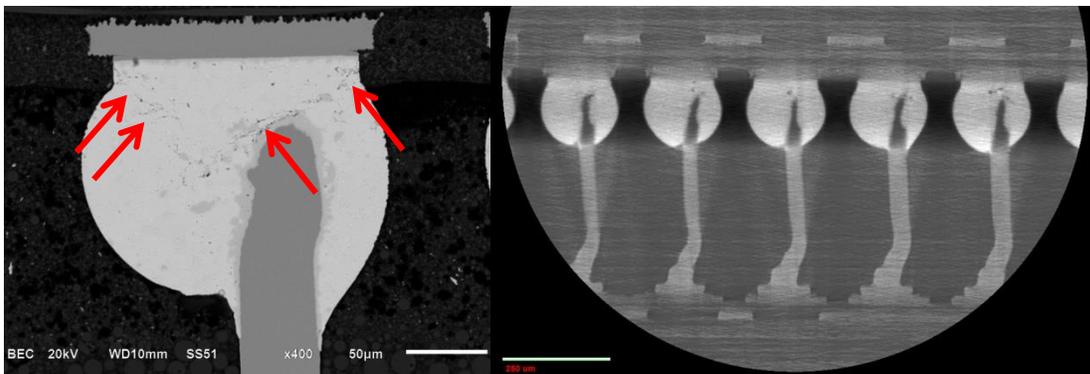
Figure 1(a): Cross Sectional SEM Image of high resistance interconnect. (b) XRM Image of multiple resistance interconnect.

Pure metal systems mixed with solder are prone to electro-migration defects and Kirkendall voids near the interface of solder and metal. Additionally, we know from careful characterization of the BVA joints that there is an intermetallic compound at the interface of the Cu wire and at the substrate Cu pad. Intermetallic compounds are brittle and tend to be sources of crack initiation; questioning the true root cause analysis.

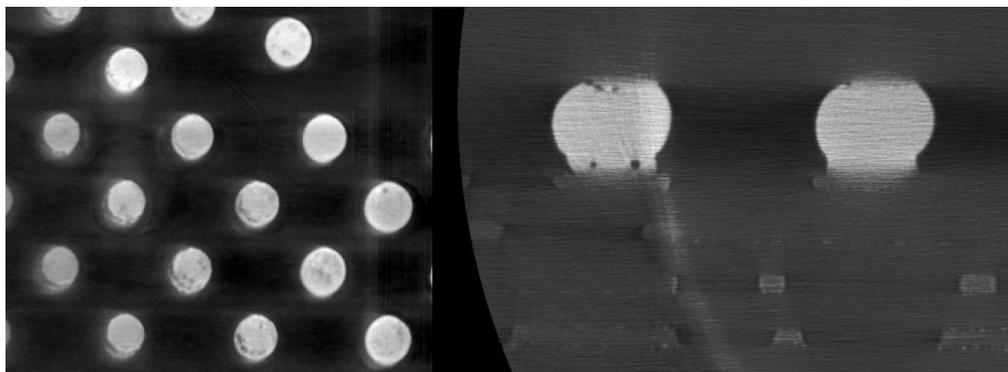
Therefore, we scanned additional packages on the same board that did not show increased electrical resistance with a Versa 510 X-ray microscope (XRM) to obtain three dimensional images of the many interconnects on the remaining packages. The virtual cross sections of these parts are shown in Figure 2. In these images all of the voiding and or cracking is occurring at the tip of the wire and solder joint interface. This definitively shows that the early stages of voiding and or cracks within the solder occur near the tip of the wires. Therefore, the original SEM image (Figure 1) with cracks across the entire interconnect at the edge of the joint were not able to explain the whole story. In fact, the strength of XRM is that we can survey many interconnects non-destructively throughout the environmental stress conditions and visualize crack propagation. Preserving the part without disturbing the crack is immensely valuable. With the XRM technique, we image and analyze the defects in the local environment and the failure mode is preserved. In contrast, SEM imaging requires physical cross-section which may alter the defective areas. Mechanically stressing a package can lead to further growth of already existing cracks. Therefore, we have moved to the XRM method, where we screen samples throughout the cycles, enabling us to visualize possible early failures and track them over the cycles. Additional images showing the three dimensional voided areas around the tip will be discussed in detail.

Figure 2 (a) Top View of 3D X-ray images and, b) virtual cross-section of the interconnects
