Peri-implantitis treatment with laser under magnification Clinical case presented by Dr. Ariel Savion, D.M.D, LL.B, M.Sc, I.C.O.I

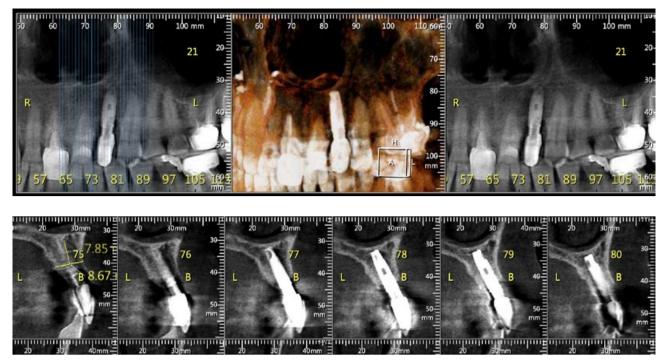
Diagnosis: Clinical examination of the implant site under magnification by periodontal probe revealed a buccal probing depth of 8 mm, buccal recession of 2 mm, while bleeding on probing and exuding pus. The buccolingual crown mobility was less than 2 mm. The width of keratinized tissue was 3 mm and it had a thick biotype. By examining the occlusion, it was found that there was no heavy occlusion or overloading at the implant site. The patient had maxillary midline shift to the right. Therefore, a poor prosthesis design resulted in patient dissatisfaction and esthetic failure. Radiographs CBCT revealed bone loss to the level of 3 mm around the implant.

Fig. 1 – CBCT pre OP

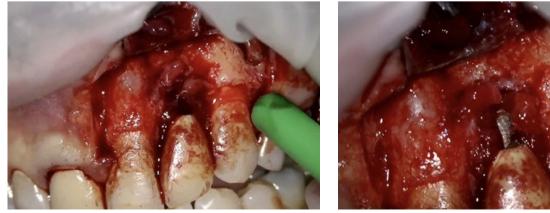
Fig. 2 - Peri-implantitis after mucoperiosteal flap with vertical releasing incision

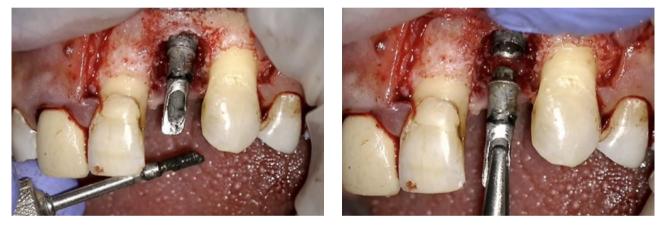
Fig. 4 - Abutment removal

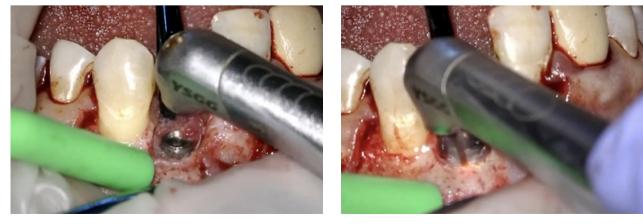
Fig. 5 – Granulation tissue removal with Tip MZ6, 14 mm length

Implant surface debridement was performed in non-contact mode, using an MZ-6 tip of 600 µm in diameter at 1.25 W, 80% water, 60% air, and frequency of 50 Hz in a direction perpendicular to the implant surface and 5 mm from the implant surface. The area was copiously irrigated with normal saline.

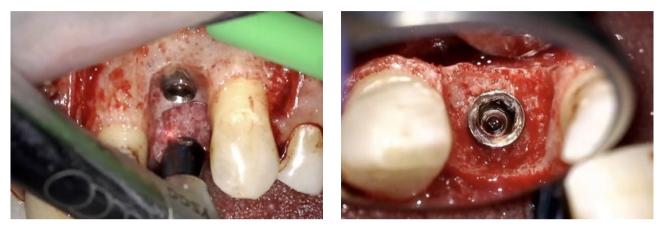
Fig. 6 - Three-dimensional view around implant

Treatment: Local anesthesia was given (2 ml Articaine hydrochloride 4% with 1/100,000 adrenaline). The patient and operating staff wore special Er,Cr:YSGG laser–protective eyeglasses. Highly reflective instruments or instruments with mirrored surfaces were avoided during laser beam application (to avoid reflections of the laser beam). After flap reflection, it was found that the buccal cortical plate had resorted to about 3 mm, and fibrous granulation tissue was present on the three-dimensional sides of the implant. Granulation tissue was removed using the laser. After complete removal of the fibrous granulation tissues, the osseous defects became clear to the third implant ration. Therefore, the defect was a combined osseous defect.

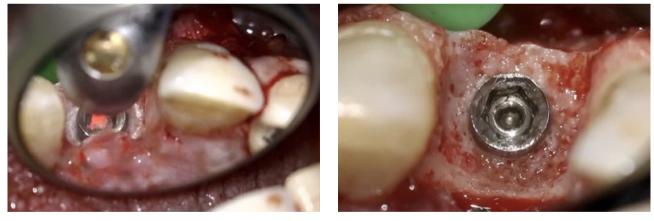
Fig. 7 – Laser emission inside of implant for decontamination

Regenerative osseous surgery was performed using an Er,Cr:YSGG laser (2,780 nm) at different settings to open the flap, remove the granulation tissue, perforate the bone, and clean the implant surface. A bone graft and a bioabsorbable membrane were used for bone regeneration.

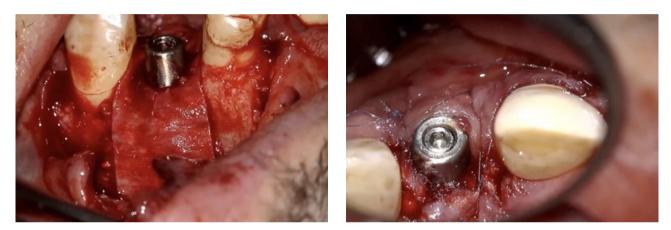
Fig. 9 – Suture 5/0 nylon

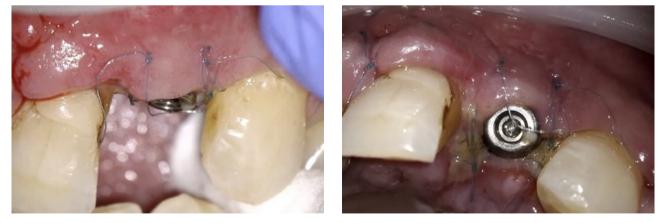
Fig. 10 – After 10 days

Post-operative recommendation: Amoxicillin, 500-mg capsules, three times daily for seven days and Ibuprofen, 400-mg tablets, as needed were prescribed for the patient. The patient was instructed to avoid eating hot food for the first 24 hours. Normal oral hygiene procedures were performed by the patient using a soft brush and 0.12% chlorhexidine mouthwash. Sutures were removed after 10 days.

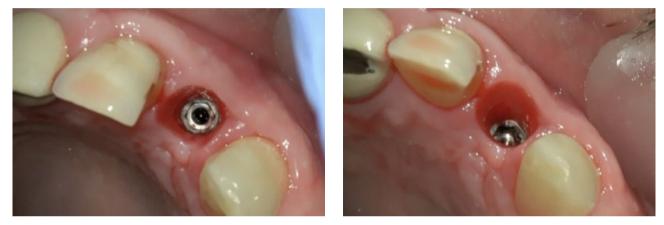
Fig. 12 – Before final restoration

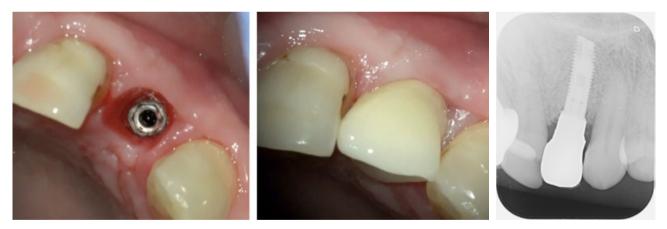
Fig. 15 – Final outcome

Conclusion: At three, six, and 12 months postoperatively, there was no reported complication, with probing depths of 3 to 5 mm, less than 1 mm recession, no bleeding loss or implant mobility, and good bone formation. The optimal result of periimplantitis treatment is regeneration of the lost implant supporting hard and soft tissue.

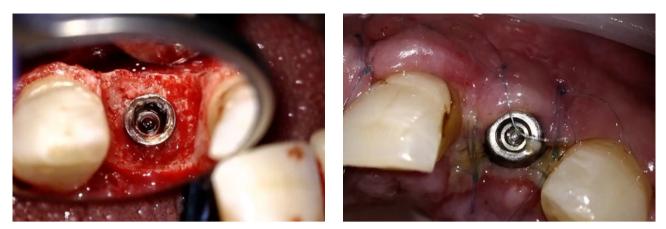
Fig. 16 – Left: Before bone regeneration (10x); right: 10-day healing period (suture 6/0 monofilament, non reservable)

To achieve proper regeneration, a few factors should be considered. These factors include sterilization of the wound site, defect size and topography, space maintenance, graft immobilization, primary soft tissue closure, rapid revascularization, and sufficient healing time. Therefore, complete regeneration of peri-implant defects can only be ensured with the use of bone graft materials following implant surface decontamination.

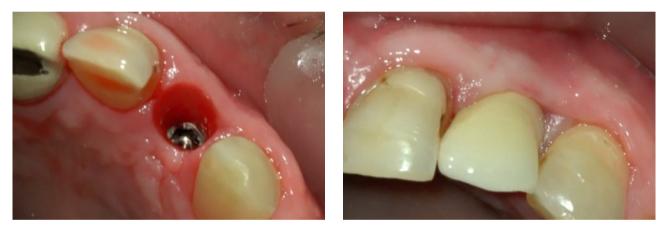
Fig. 17 – Left: Soft tissue before final restoration; right: Final zirconia monolithic crown

A bone graft (0.25 mm to 1 mm granules) and a bioabsorbable collagen membrane as GBR were used to fill the osseous defects and to cover the exposed implant surface. The crown was replaced with a new zirconia abutment and cemented crown made of monolithic zirconia, which met the patient's expectations in terms of shape, dimensions, and color.
