Package Optimization and Failure Analysis with 3D X-ray Microscopy

Author: *Carl Zeiss X-ray Microscopy
Pleasanton, California*

Date: February 2015

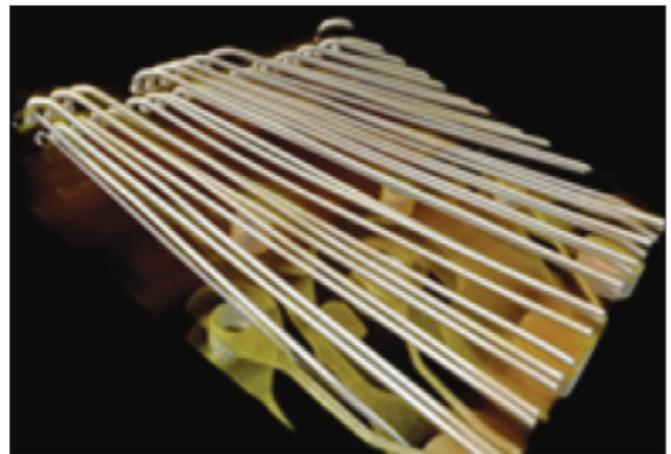
Figure 3: Wire bond, shorts open – Xradia Versa
